Viking '75 Project

BALLOON LAUNCHED DECELERATOR TEST PROGRAM POST-FLIGHT TEST REPORT

BLDT VEHICLE AV - 1

11 September 1972

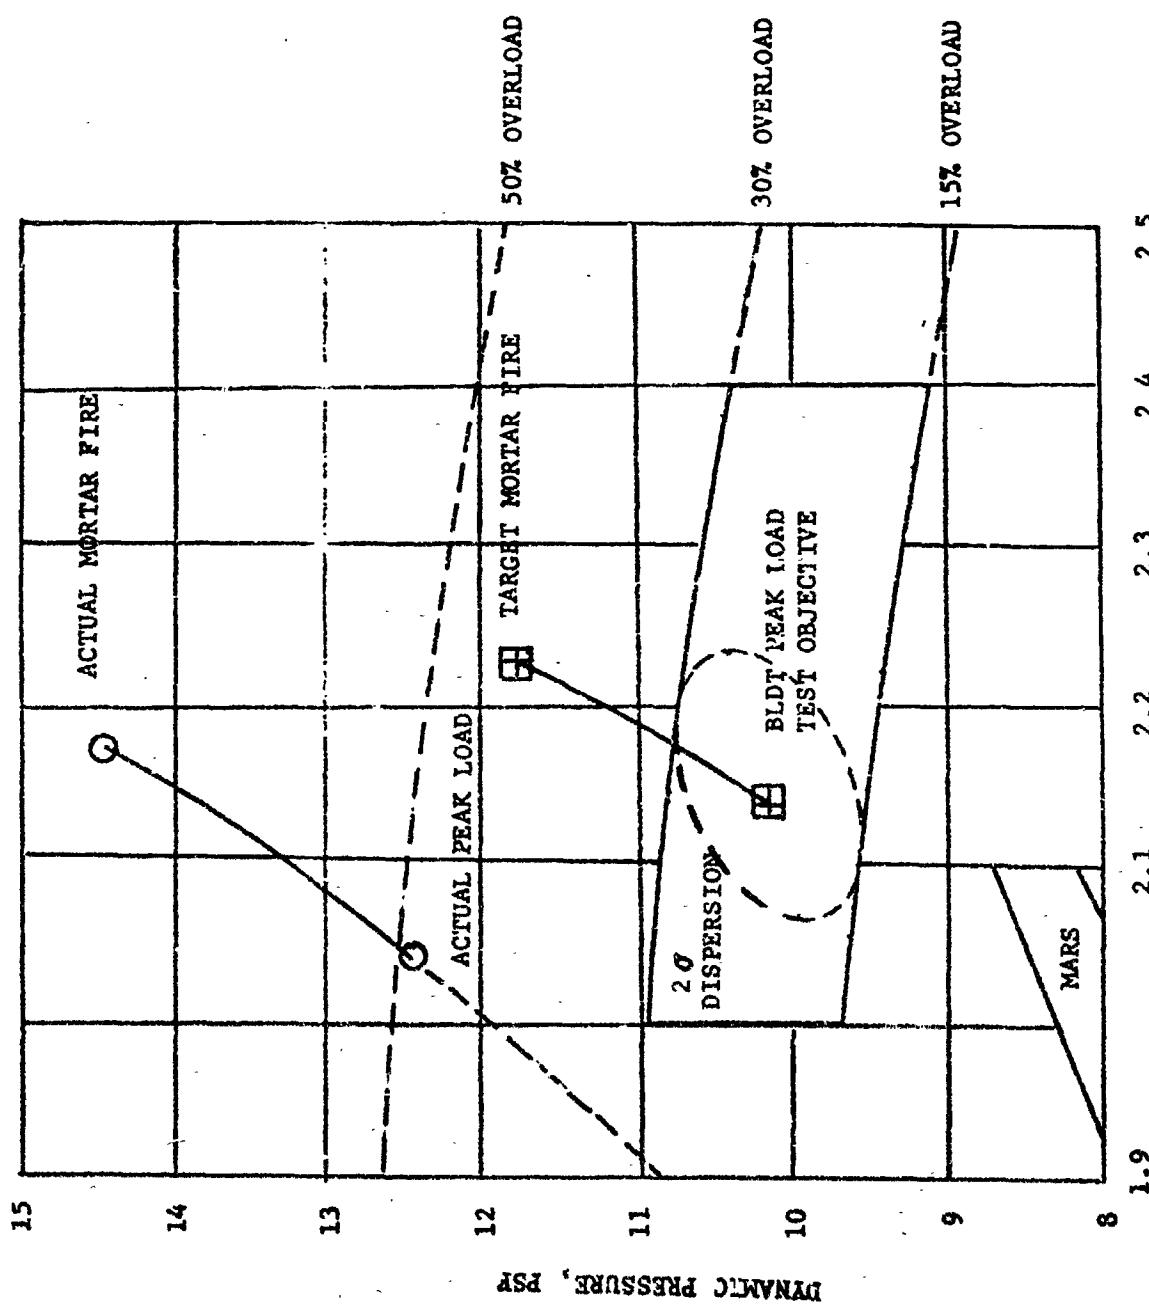
FIGURE VI-1

The actual flight condition, also shown on Figure VI-1, is at a dynamic pressure in excess of the established envelope which resulted in an over-test condition necessitating the reflight of the supersonic mission.

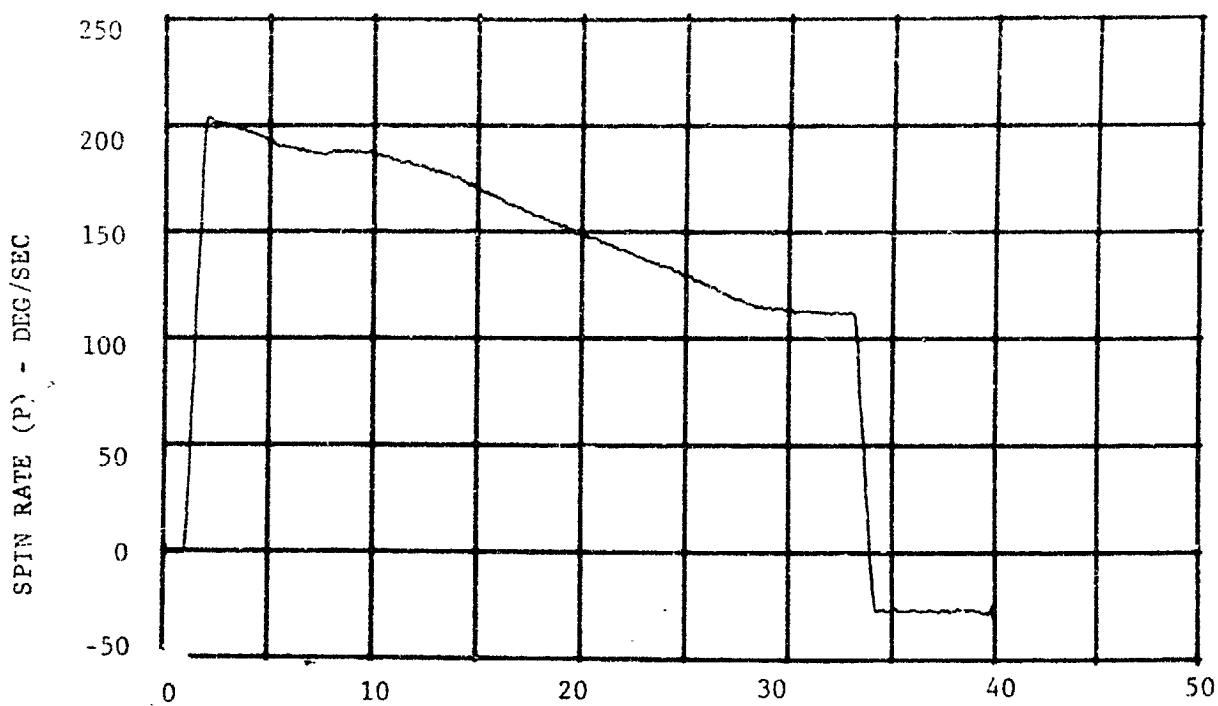
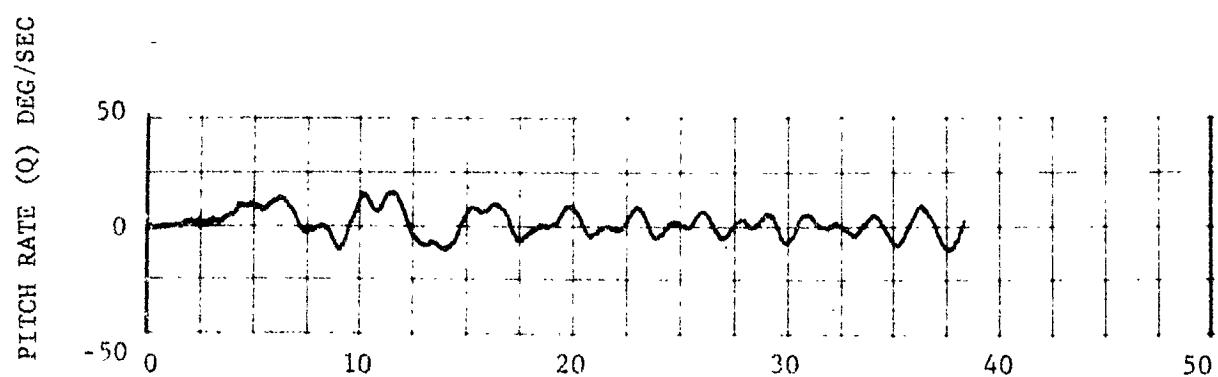
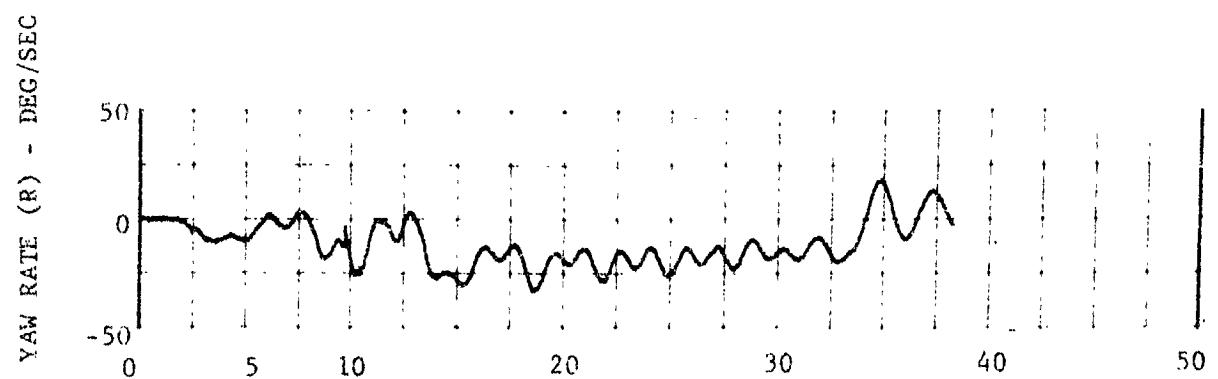
FIGURE VI-5 GYRO DATA DURING POWERED FLIGHT

b. Spin Rate - The spin rate decay was interrupted at 7 seconds (see Figure VI-5) for about 3 seconds. This phenomenon can occur due to a number of reasons. The most obvious is an external roll torque due to either aerodynamic forces or propulsive thrust misalignment. A further source was noted during 6 DOF simulations of the effect of cross products of inertia. Previous predictions of flight performance, such as presented in Reference 11 showed such tendency. The magnitude of cross products necessary to duplicate the flight data is estimated to be less than 4 slug-ft². The asymmetric pitch/yaw oscillations are also indicative of a principle axes asymmetry of which the cross products of inertia are a measure. These gyro data can also arise from misalignment of the gyros relative to the principle axes of the vehicle.

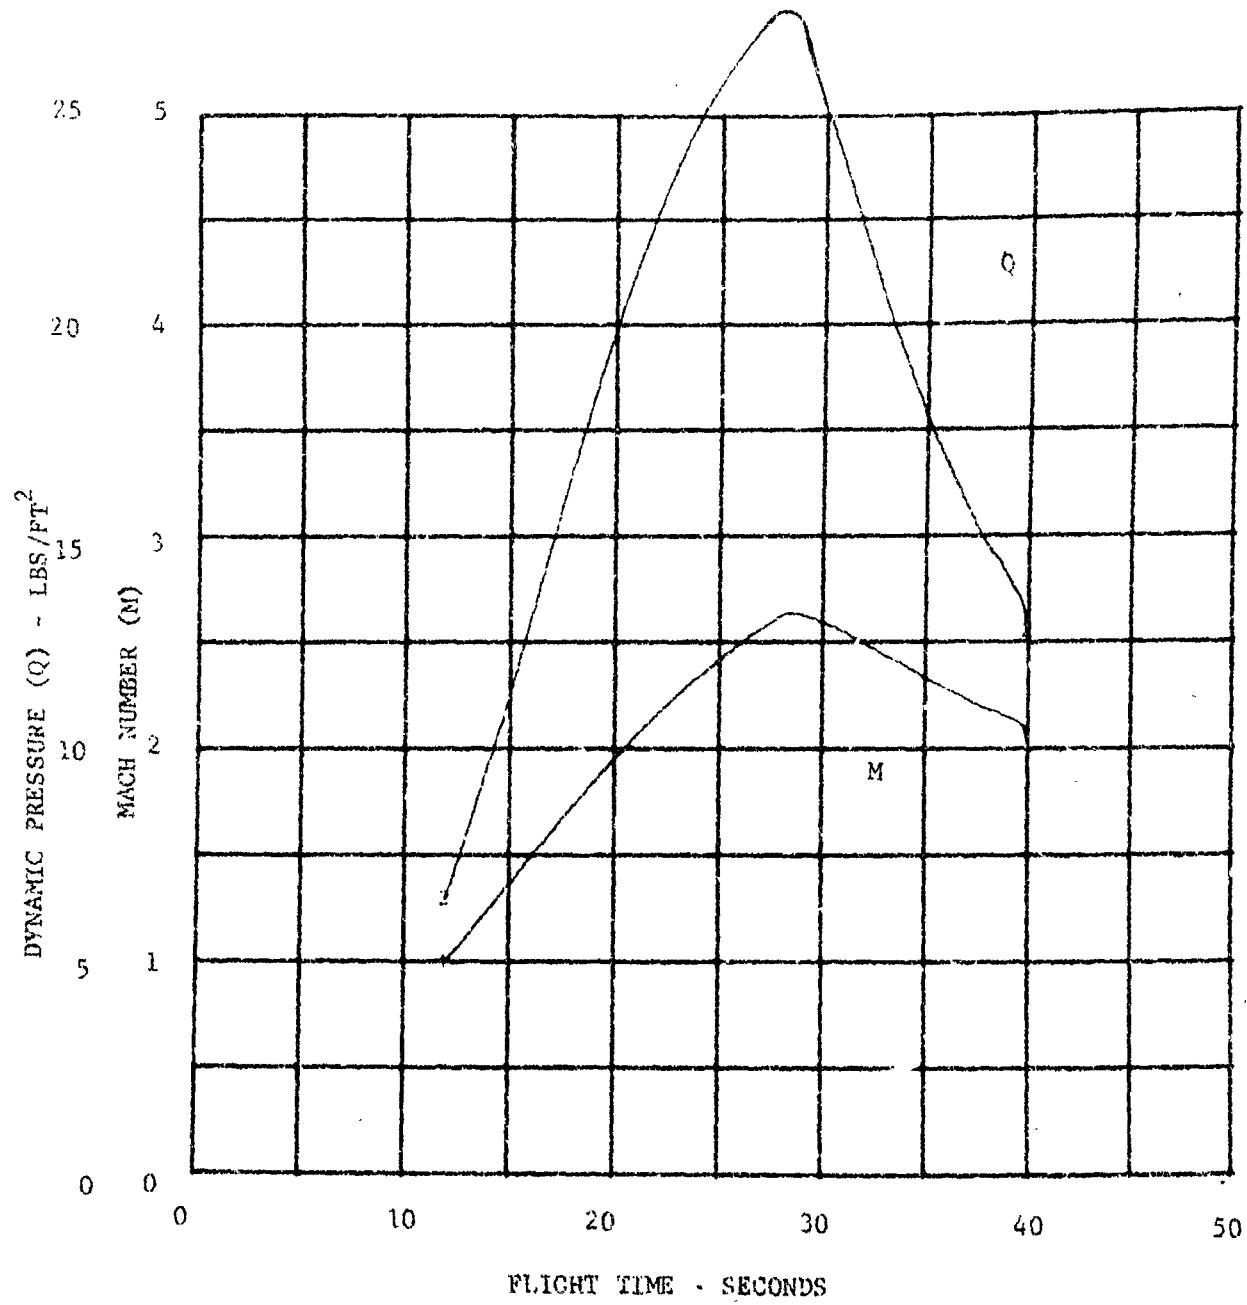
FIGURE VI-11 STEP TRAJECTORY RECONSTRUCTION OF MACH NUMBER AND DYNAMIC PRESSURE

STEP reconstructed trajectory provides a very accurate measurement of altitude and velocity. Combining this value with the met data, velocity relative to the wind, Mach number and dynamic pressure was compiled. Time history of altitude, velocity, Mach Number and dynamic pressure are shown in Figure VI-10 and VI-11. Figures VI-12 and VI-13 show the body and velocity vector orientation versus time. The conditions established by STEP at mortar fire and peak load, provided in Table VI-2, show that the flight performance did not meet the requirements for dynamic pressure as required in Figure VI-1.

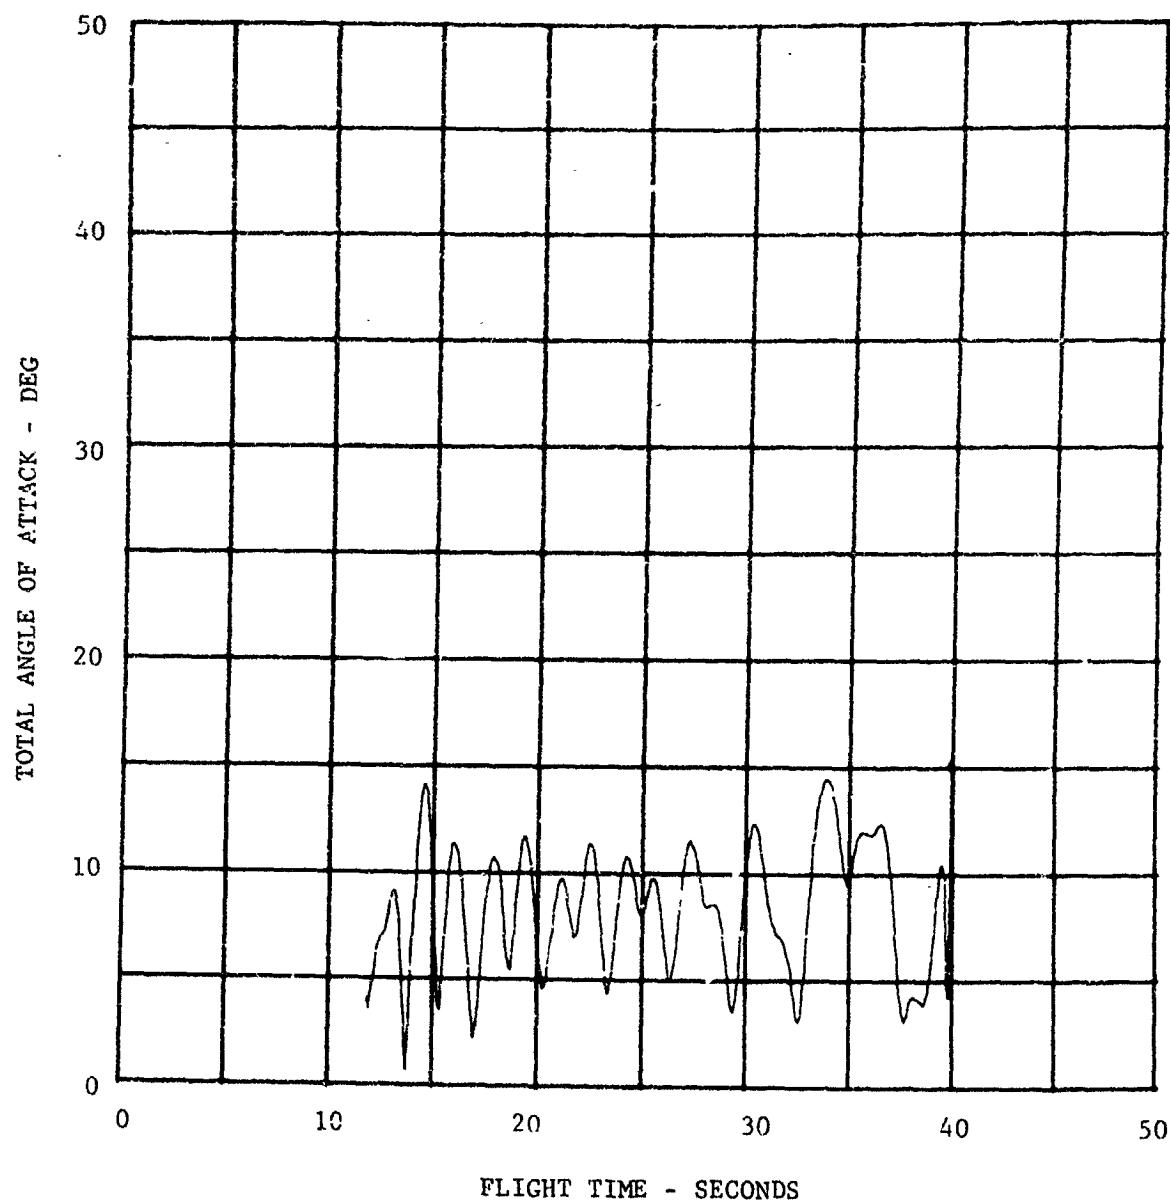
FIGURE VI-15 STEP TRAJECTORY RECONSTRUCTION OF TOTAL ANGLE OF ATTACK

The angle of attack, sideslip and total angle of attack are shown in Figures VI-14 and VI-15. The total angle of attack shown on Figure VI-15 never exceeds the value of 15° which is less than the required value of $\leq 17^{\circ}$. The value provided by STEP of 7° at mortar fire differs from the value of 13° derived from analysis of the aft facing camera films. Small roll errors integrated across the time period of T+12 seconds to T+38 seconds will cause small errors in the orientation of the body axis which look like a time shift to the STEP program. This small shift at a time when the angle of attack is changing rapidly provides a large difference in the value of angle of attack.

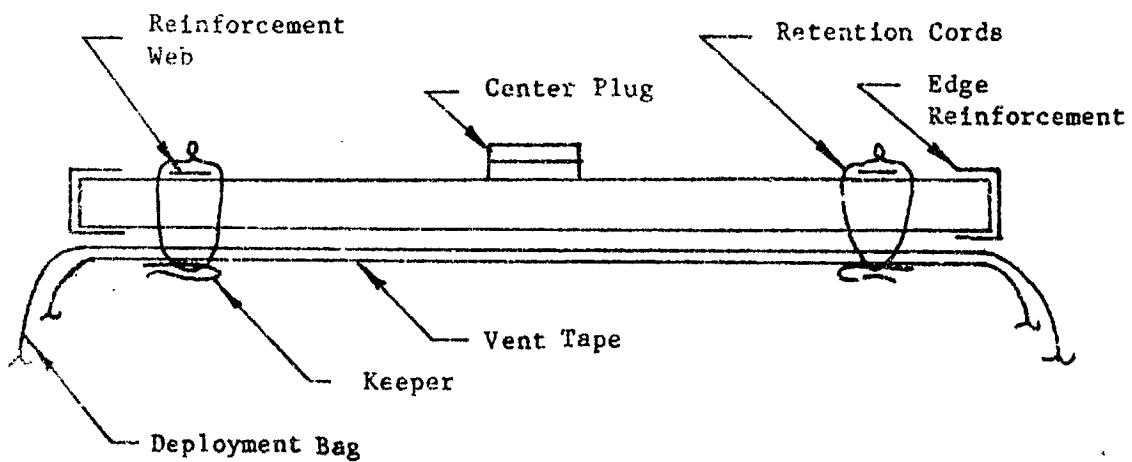
The abraised Min-K buffer is associated with the missing deployment bag. The attachment of this to the chute is as follows:

The buffer was severely abraided leaving the edge reinforcement held to the reinforcement web on the buffer with the quartz threads that make the buffer sandwich. The retention cords holding the buffer to the chute were all intact. The abrasion of the buffer is as expected in the supersonic environment and happens well after the purpose of the buffer has been served; that is to act as a buffer between the pack restraint straps and the pack and as additional thermal protection.

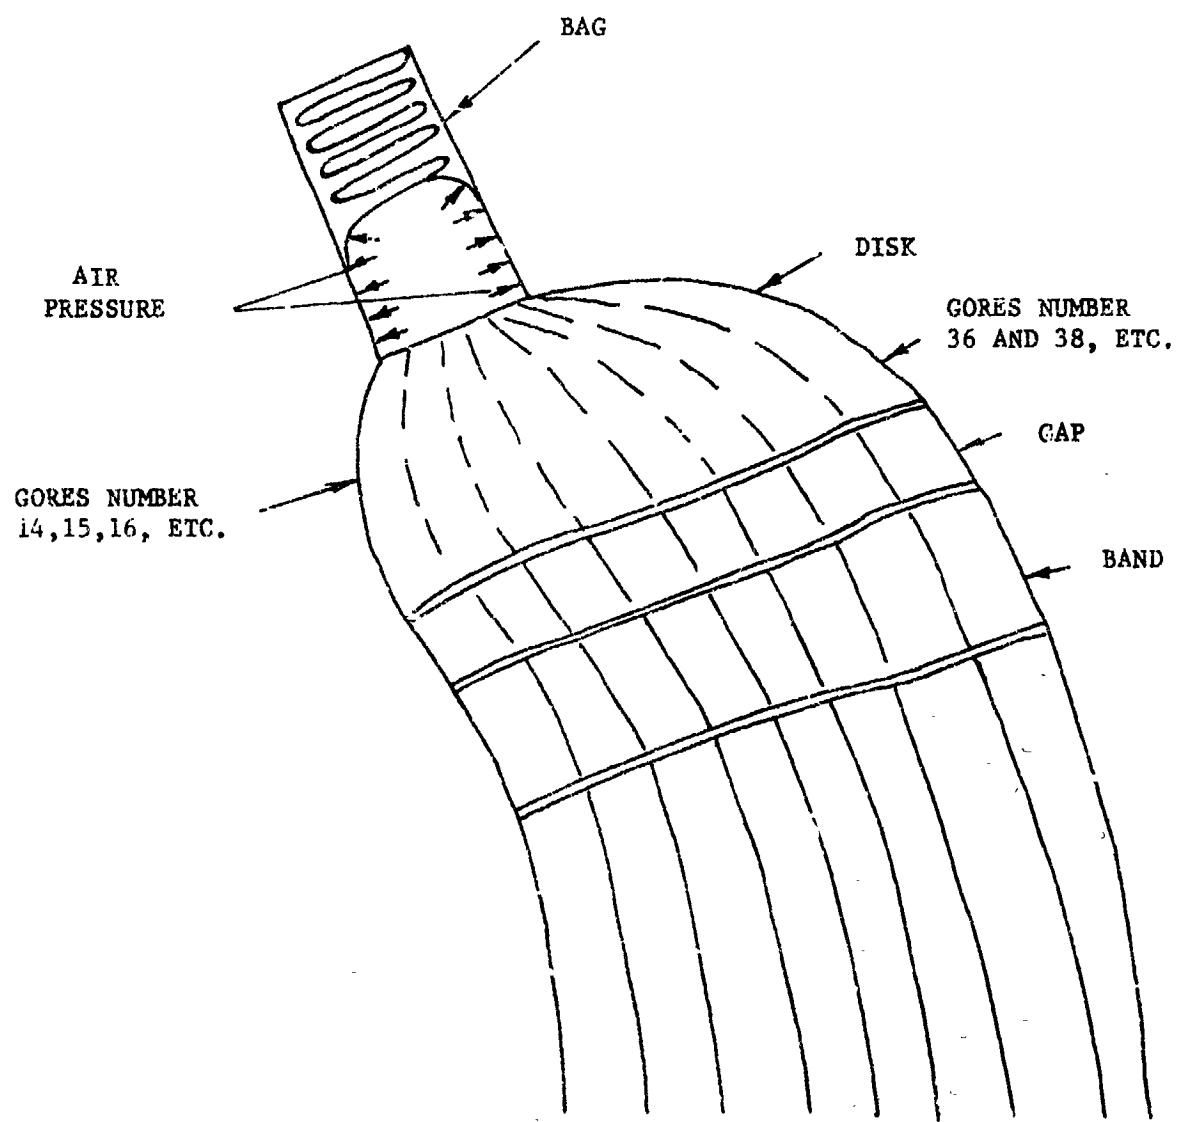
FIGURE C-1 SKETCH OF DISK DEPLOYMENT FROM THE BAG

- c. The mouth of the disk starts to inflate while a large amount of disk is still packed in the bag. The appearance here is that of an inflating "cone" with its base at the disk edge with a definite amount of uninflated disk out of the bag and a majority still packed, see Figure C-1.

- e. As the bag reverses direction and apparently moves from left to right, the disk is inflating. At approximately 1/30 of a second after the bag disappears behind the inflating disk, the major gore tears begin to come into view. These are located on the canopy side that fills first and is most rearward in the field of view so that the nearer canopy regions must subsequently unfurl and inflate in order to bring the far side into view. First evidence of the above major tear is seen at one o'clock on the film whereas the apparent left to right movement of the bag is horizontal on the film and, the attached bag is never observed on the right of the canopy apex or has the bag had sufficient time to travel to the vicinity of the tear. Hence, impact of the bag upon the canopy disk is considered improbable.

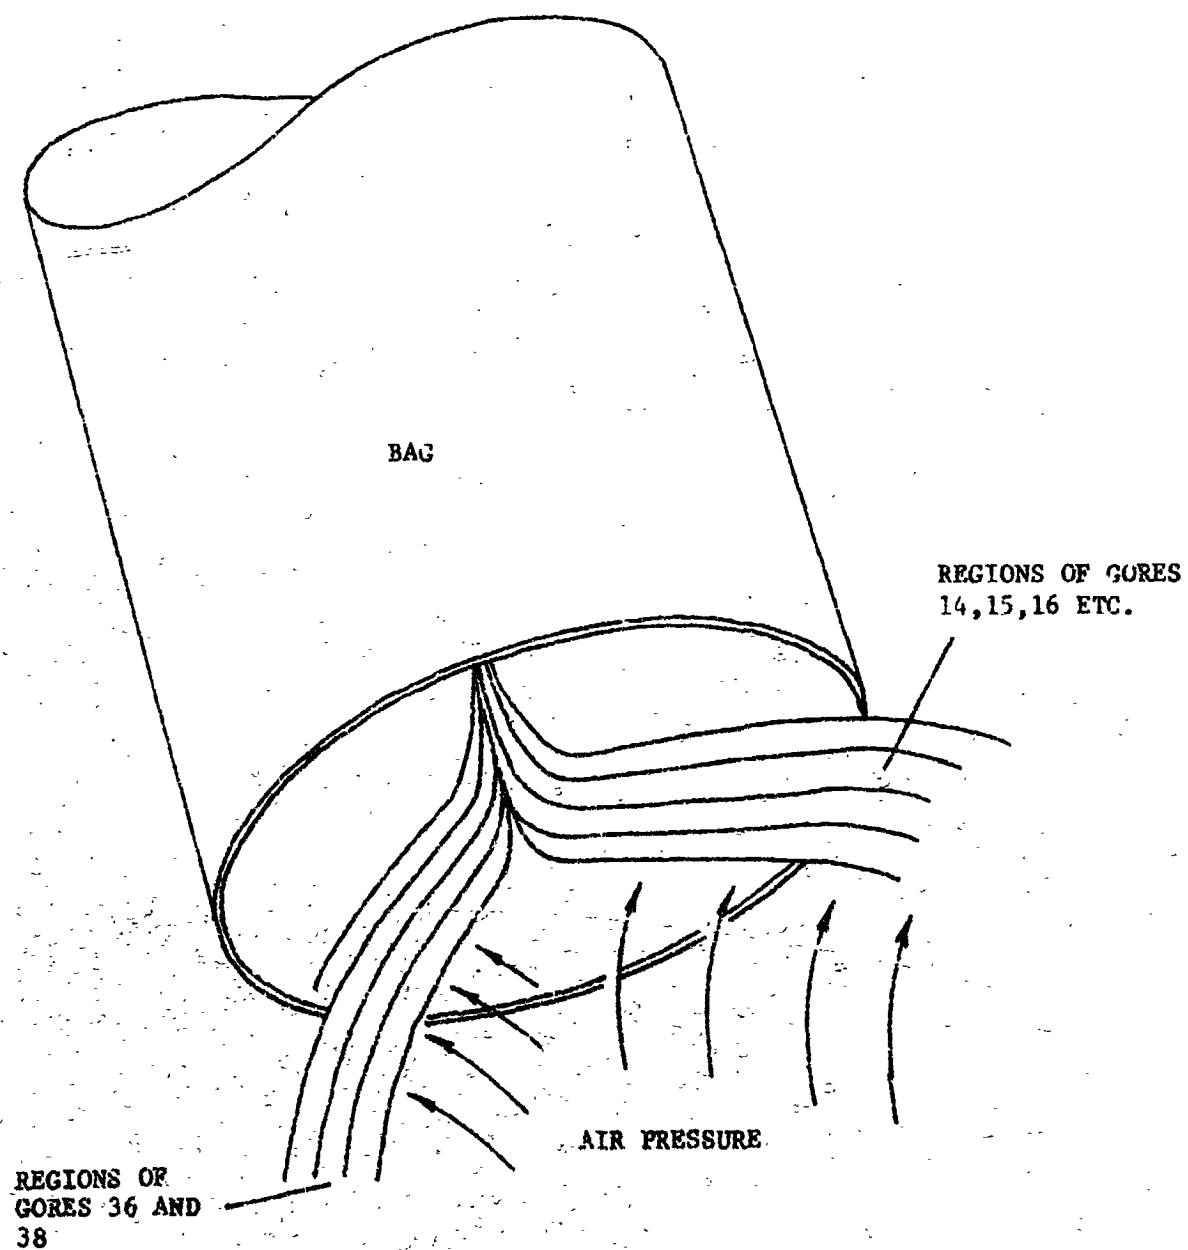
FIGURE C-2 SKETCH OF PANELS C AND D DISK AREAS DEPLOYING FROM BAG

The following observations strongly indicate that the primary tears did not result due to only excessive pressure stresses.

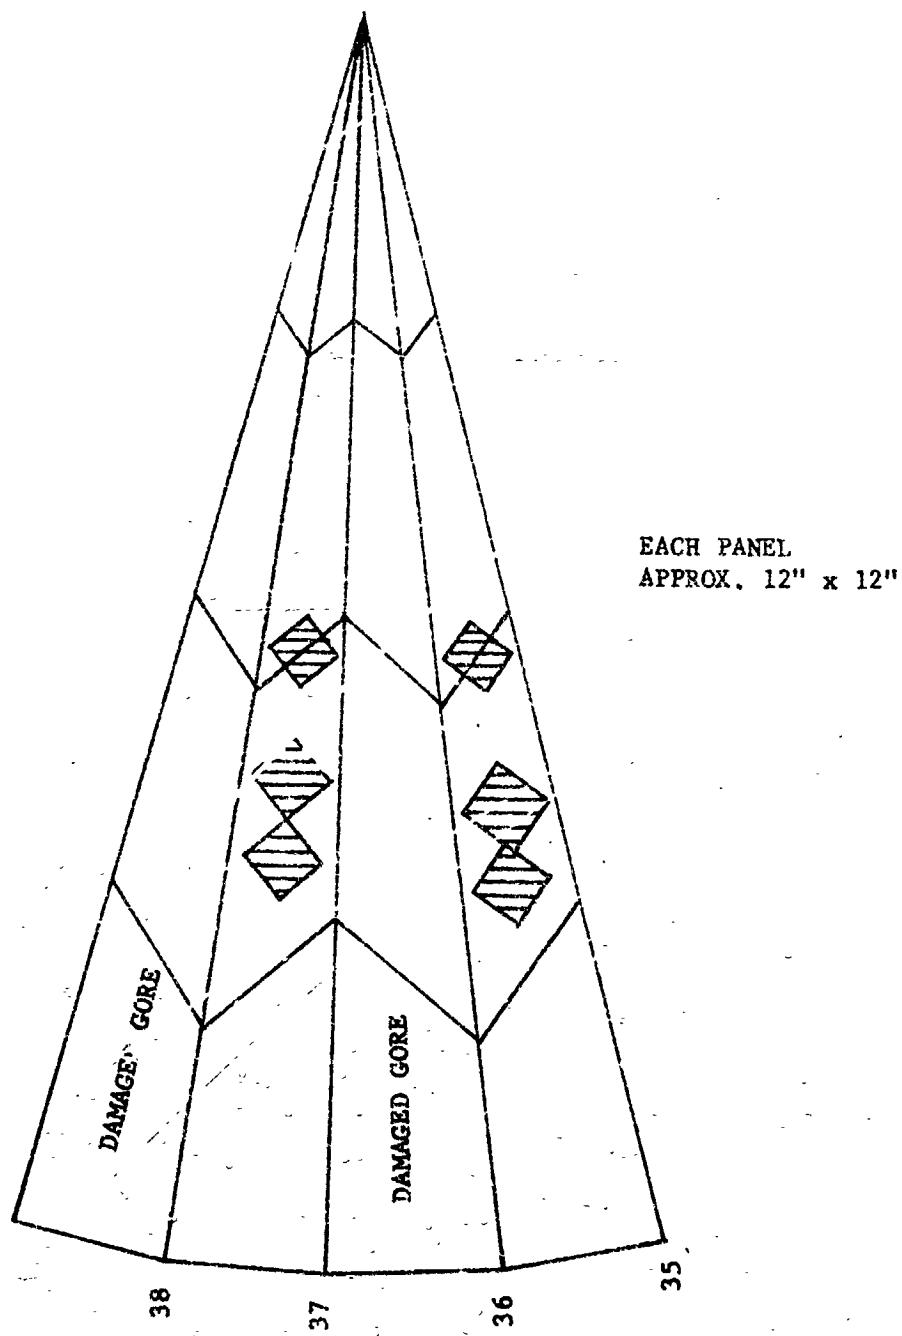
FIGURE C-3 LOCATION OF TEST
SPECIMENS

Consequently, test specimens were cut from the chute as shown in

Figure C-3.

All test specimens were ravelled down to an effective width of one inch. The gage length was six inches and the jaw separation rate was 12 inches per minute.

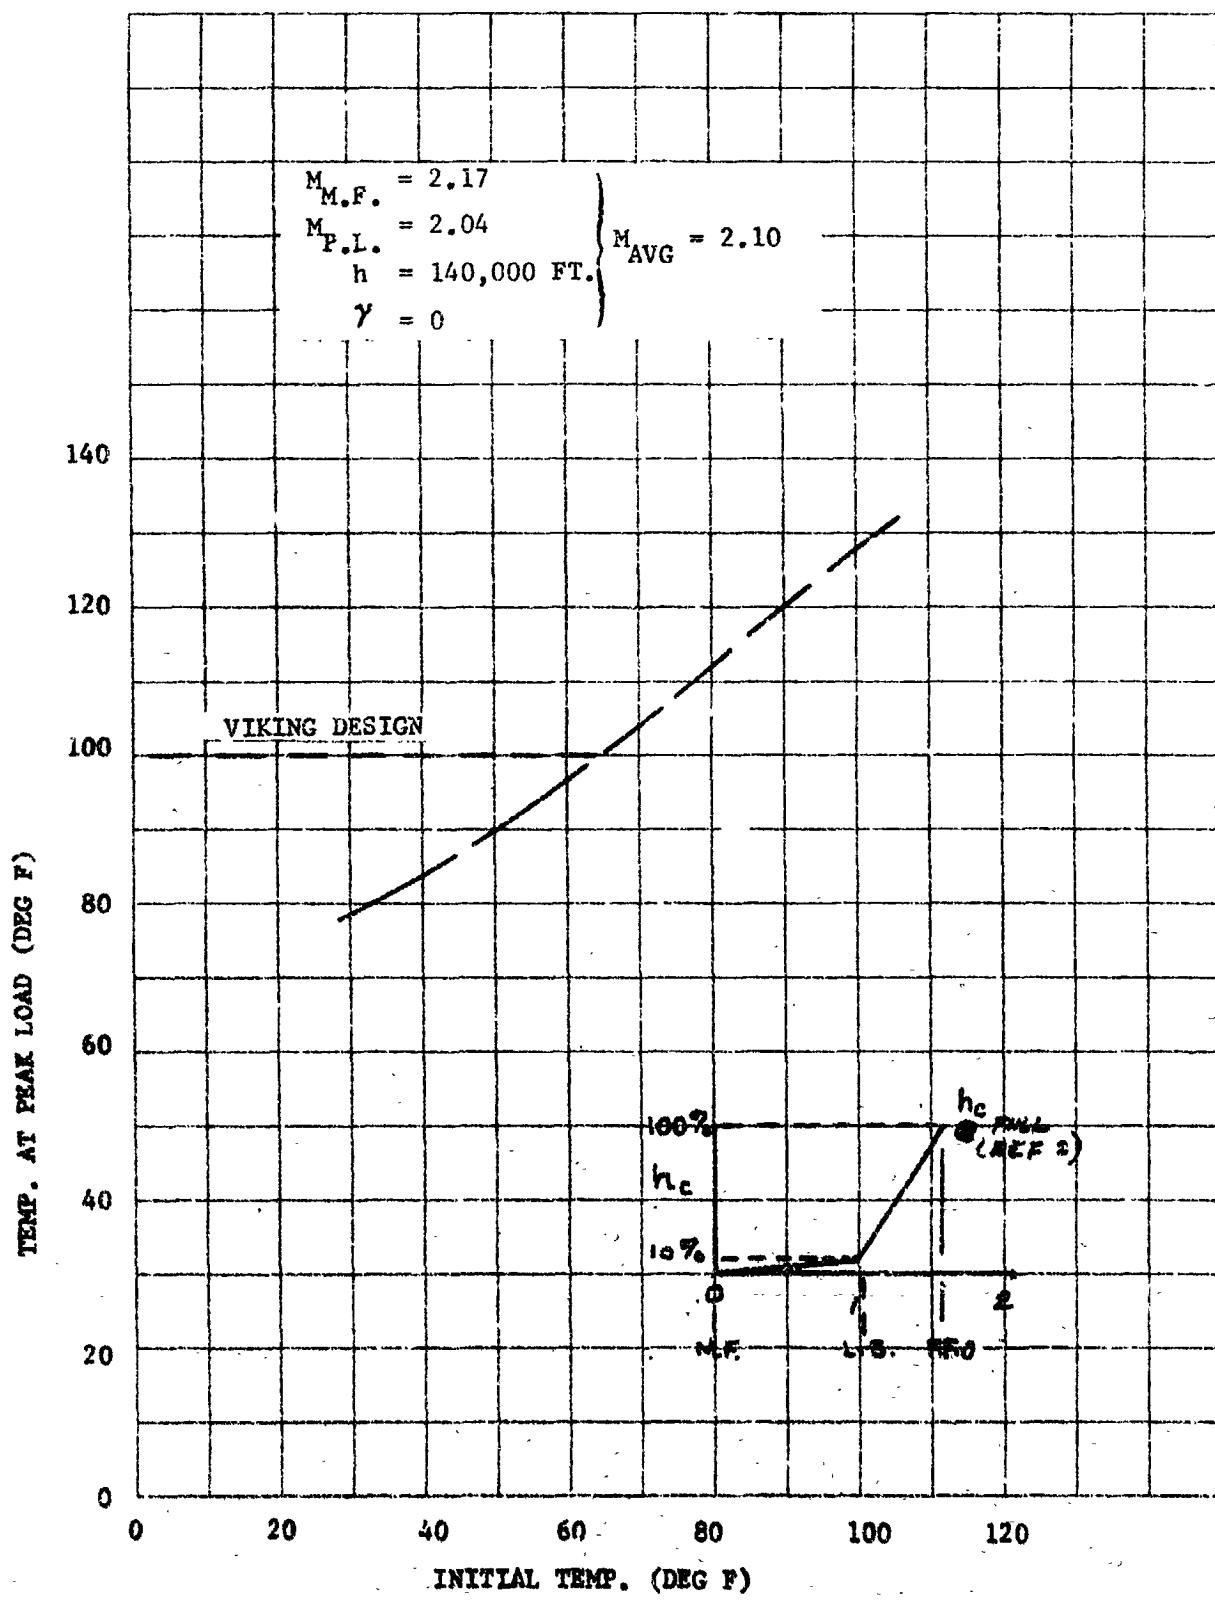
FIGURE C-4 AERODYNAMIC HEATING EFFECT - BLOT TEST NO. 1

Since these conditions closely approximate conditions assumed in Reference (1), the results of that memorandum were extended to the present case. The results are shown in Figure C-4 and indicate the temperature effect to be relatively minor especially considering the fact that damage was apparent from the films prior to the time of first full open. It is noted, however, that very limited heating is assumed to occur during line stretch and that the inflation time is very short. An estimate of Bobbitt assuming an equilibrium surface temperature is achieved produces a temperature of 159°F . If it is assumed that even higher heating rates exist prior to full open than do after full open at a given set of conditions (a possibility suggested by Bobbitt), then even higher

temperatures could be expected. The stagnation temperature in a Mach 2 flow at 140,000 feet is 375°F. This, of course, represents an upper limiting value.
